**Flood Control Project Maintenance
Levee Inspections**

Maintenance Issue Types Only, Levee Inspection Report By Mile - Spring 2018

Reclamation District No. 0349 Sutter Island

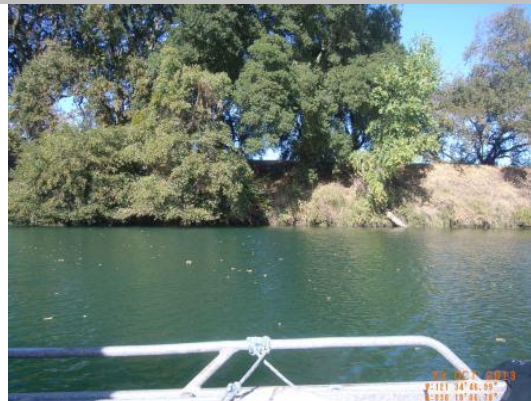
Photo 1 of 1 : SP_2018_RD0349_205_9_20180305_00009.jpg

LM Start	0.34	Rating **	A/W	Issue No.	9
LM End	0.39	Issue Type +	Ma	Location *	WS
Category	Supplemental			GPS Latitude/Longitude	
				Start	End
Item	2015 USACE Erosion Survey, DRAFT			38.302358 °	38.301772 °
				-121.579707 °	-121.580093 °
DWR ID	DWR_RD0349_02_s_2016_9				
Comment Code					
Inspector Comment					
2007 - Slow erosion, probably due to wave wash and fluvial erosion. Site has likely been here for awhile but was unseen due to boats parked in front. 2015: Large tree popout, scarp reaches crown of levee. [2015 Site ID: STM_25-8_R]

USACE 2013 Photo #1

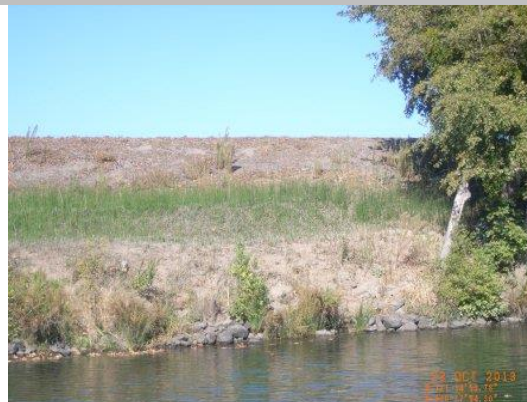
Photo 1 of 1 : SP_2018_RD0349_205_13_20180305_00012.jpg

LM Start	0.60	Rating **	M	Issue No.	13
LM End	0.72	Issue Type +	Ma	Location *	WS
Category	Supplemental			GPS Latitude/Longitude	
				Start	End
Item	2015 USACE Erosion Survey, DRAFT			38.298897 °	38.297384 °
				-121.581571 °	-121.582176 °
DWR ID	DWR_RD0349_02_s_2016_13				
Comment Code					
Inspector Comment					
2010 - Small maintenance, erosion into the toe. 2011 - Minor new erosion at toe. 2015: Minor new erosion at toe, new tree popout. [2015 Site ID: STM_25-5_R]

USACE 2013 Photo #1

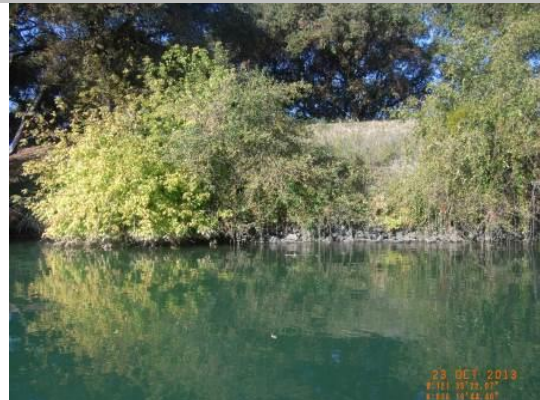
Photo 1 of 1 : SP_2018_RD0349_205_16_20180305_00013.jpg

USACE 2013 Photo #1

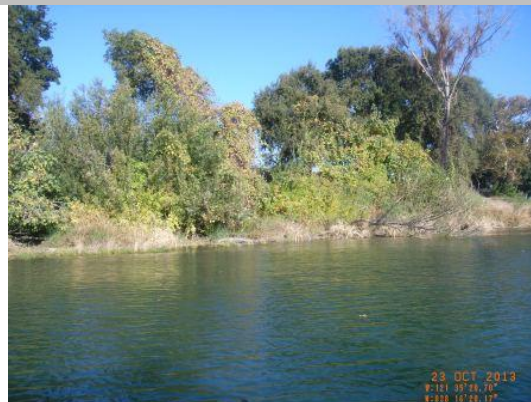
Photo 1 of 2 : SP_2018_RD0349_205_3_20180305_00004.jpg

LM Start	2.56	Rating **	A/W	Issue No.	3
LM End	2.69	Issue Type +	Ma	Location *	WS
Category	Supplemental			GPS Latitude/Longitude	
				Start	End
Item	2015 USACE Erosion Survey, DRAFT			38.273854 °	38.271998 °
				-121.588745 °	-121.589424 °
DWR ID	DWR_RD0349_02_s_2016_3				
Comment Code					
Inspector Comment					
2011 - Toe scour at the tidal zone. 2015: New tree popout and minor new erosion. [2015 Site ID: STM_23-6_R]

USACE 2013 Photo #1

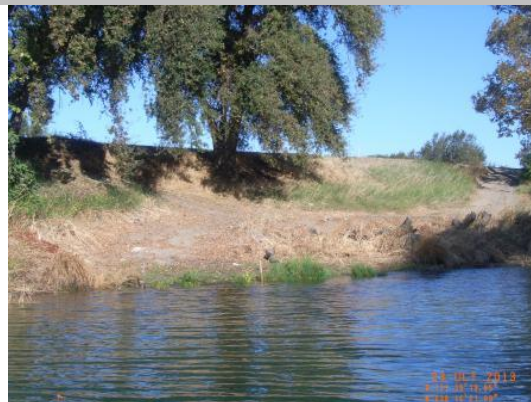
Photo 2 of 2 : SP_2018_RD0349_205_3_20180305_00005.jpg

USACE 2013 Photo #2

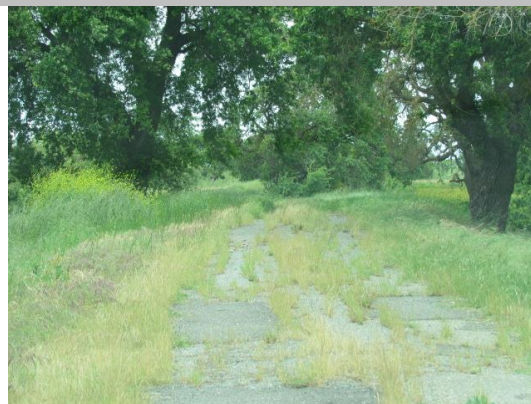
Photo 1 of 1 : SP_2018_RD0349_206_50_20180305_00014.jpg

LM Start	3.99	Rating **	M	Issue No.	50
LM End	4.91	Issue Type +	Ma	Location *	CR
Category	Earthen Levee			GPS Latitude/Longitude	
				Start	End
Item	Vegetation			38.307972 °	38.318371 °
				-121.597037 °	-121.589593 °
DWR ID	DWR_RD0349_03_s_2017_50				
Comment Code					
V9 : Keep the crown roadway free of vegetation.					
Inspector Comment					
Keep the crown roadway free of vegetation.

RD 349 Unit 4 levee mile 3.99 -6.33 crown roadway.
